## OKANOGAN POOL FACILITY ASSESSMENT

G&O #21854  
FEBRUARY 2024

**Gray & Osborne, Inc.**  
CONSULTING ENGINEERS

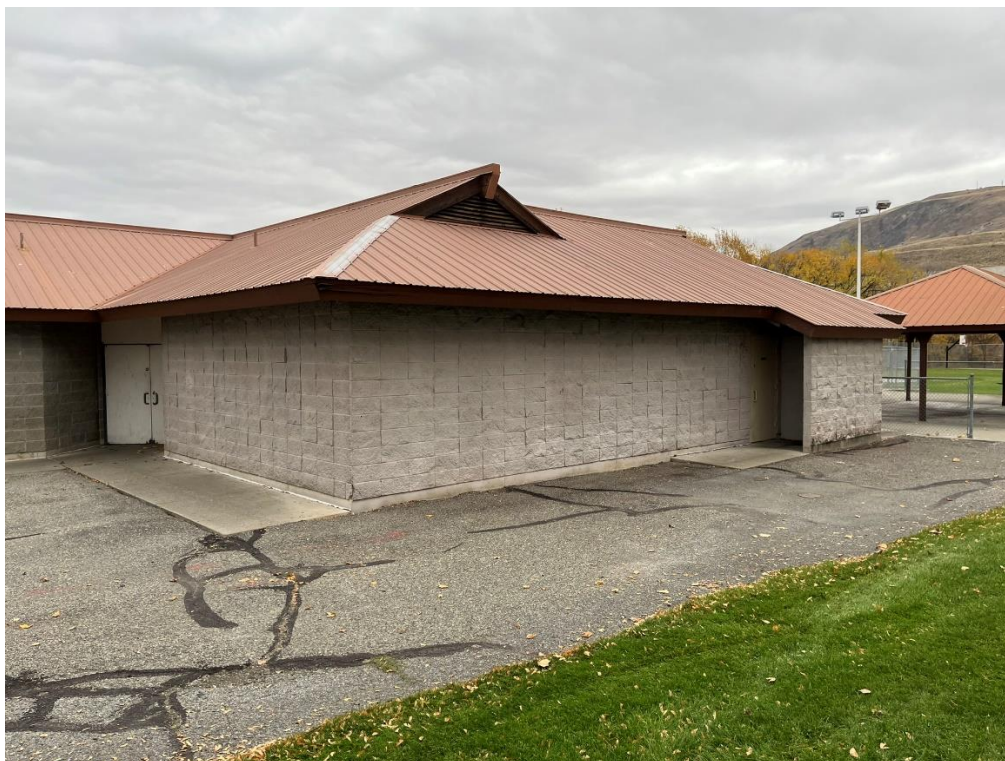
**Plate 2 – Metal Roofing Oxidation**

| <b>Observations/Issues</b> | <b>Condition Rank</b> |
|---|---|
| Metal roofing is beginning to show signs of oxidation and weathering. Some portions, such as south-facing ridge caps, have no surface coating remaining <b>(Plate 3)</b> . | Fair |

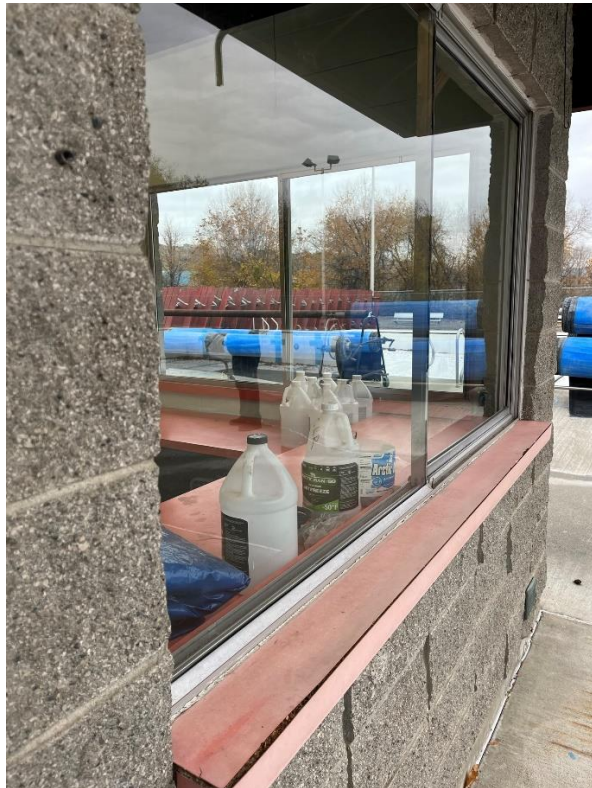
**Plate 4 – Exterior Window Sill Delamination**

| <b>Observations/Issues</b> | <b>Condition Rank</b> |
|---|---|
| Exterior, laminate window sills and window caulking are weathered and delaminating <b>(Plate 4)</b> . | Poor |

- Replace windows, window sills and caulking around the windows. Because the existing deteriorating laminate sills are under the window, the window needs to be removed to replace the sills. New windows are recommended to be fiberglass or vinyl. The new sill should be masonry to maximize its durability and service life.

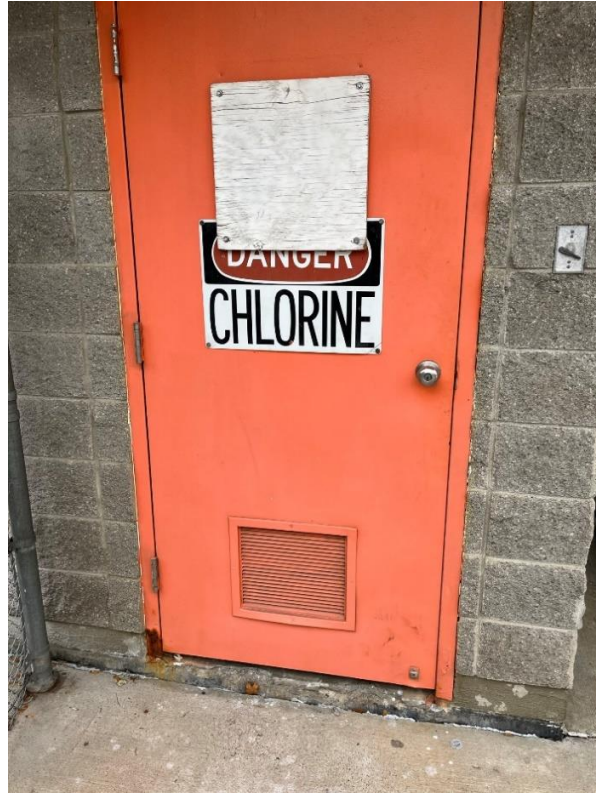
**Plate 5 – Door Corrosion**

| <b>Observations/Issues</b> | <b>Condition Rank</b> |
|---|---|
| Exterior and interior metal doors are beginning to show signs of corrosion. Several doors have had their door frames cut and removed above the floor as a temporary measure to mitigate for corrosion <b>(Plate 5)</b> . | Poor |

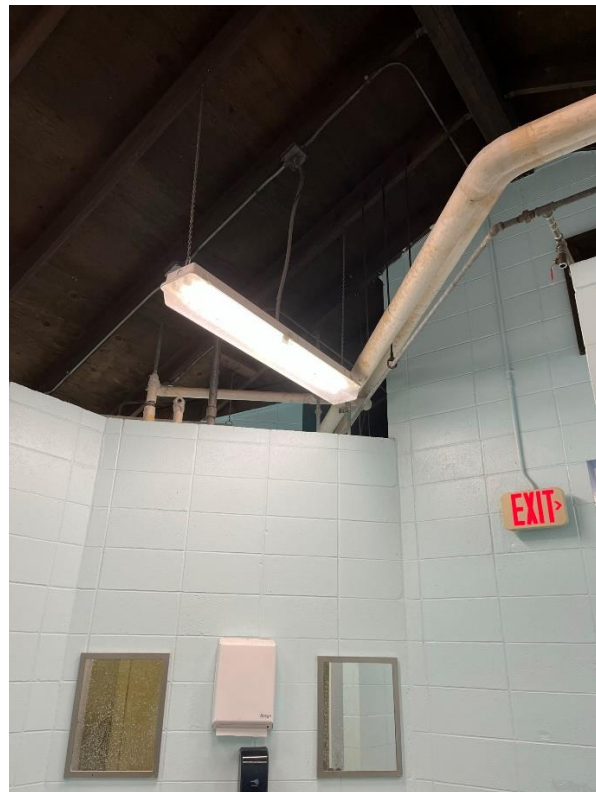
**Plate 6 – Interior CMU Walls & Wood Framing**

| <b>Observations/Issues</b> | <b>Condition Rank</b> |
|---|---|
| Interior CMU walls and underside of wood roof framing are in good shape and do not show any sign of moisture intrusion or staining <b>(Plate 6)</b> | Good |

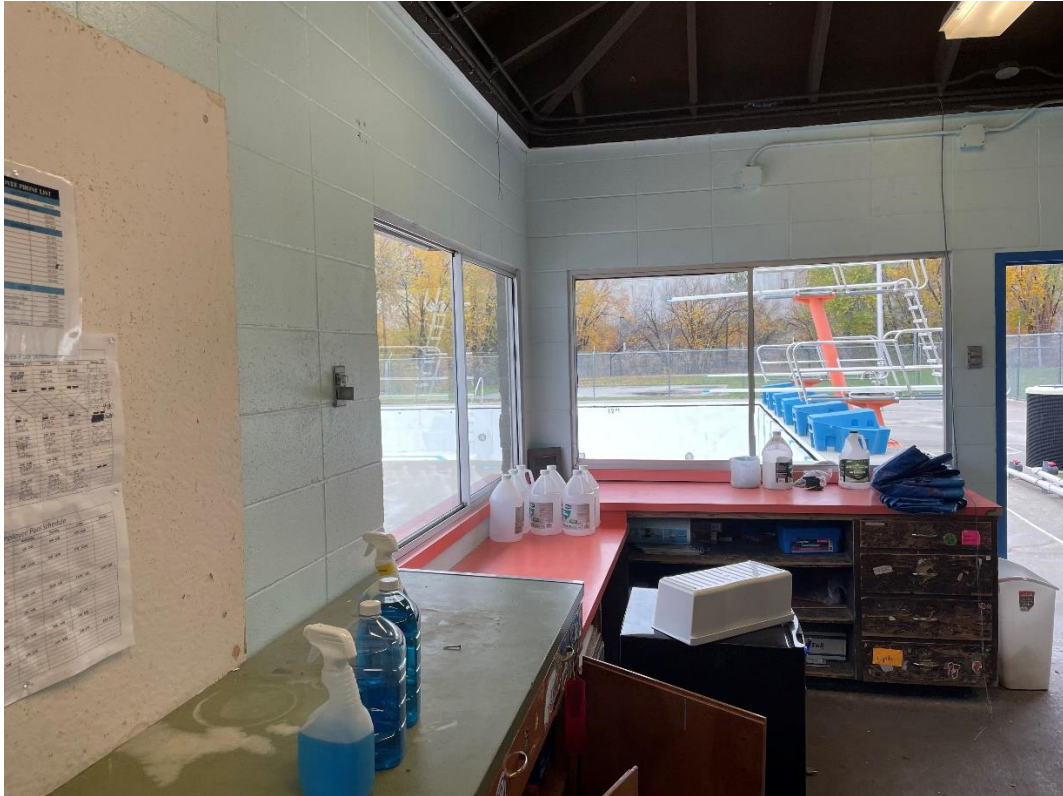
**Plate 8 – Office Counters and Cabinets**

| <b>Observations/Issues</b> | <b>Condition Rank</b> |
|---|---|
| Office area counters and cabinets are worn, delaminating, and in poor shape <b>(Plate 8)</b> . | Poor |

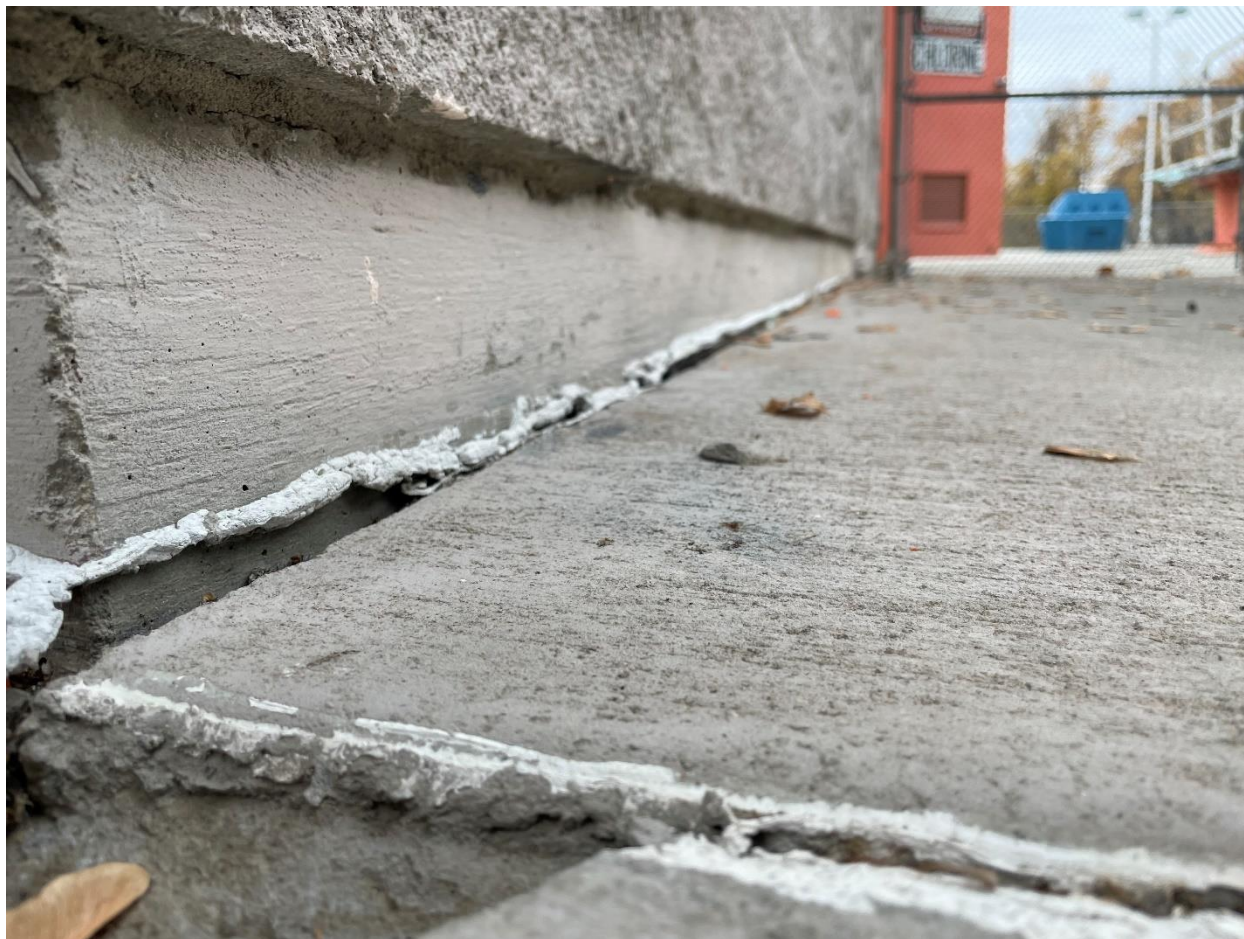
**Plate 9 – Sidewalk Settlement**

| Observations/Issues | Condition Rank |
|---|---|
| The settlement of the sidewalk is particularly noticeable at the southeast corner of the building, where sidewalk that originally was flush with the building floor at the doorway has settled more than 2”. We understand there is piping between the building and pool under this sidewalk and there is concern that a leak in the pipe may have caused some soil voids under this area <b>(Plate 9)</b> . | Poor |

In general cracking and settlement in the concrete sidewalks around the building shall be addressed with grinding and grouting to make surfaces smooth, or by replacing the affected sidewalk panels. At the southeast corner of the building where settlement of the sidewalk is most extreme, it may be prudent to remove all sidewalk panels and excavate to exposed below grade piping to verify if there is piping leakage that is creating voids under the sidewalk.

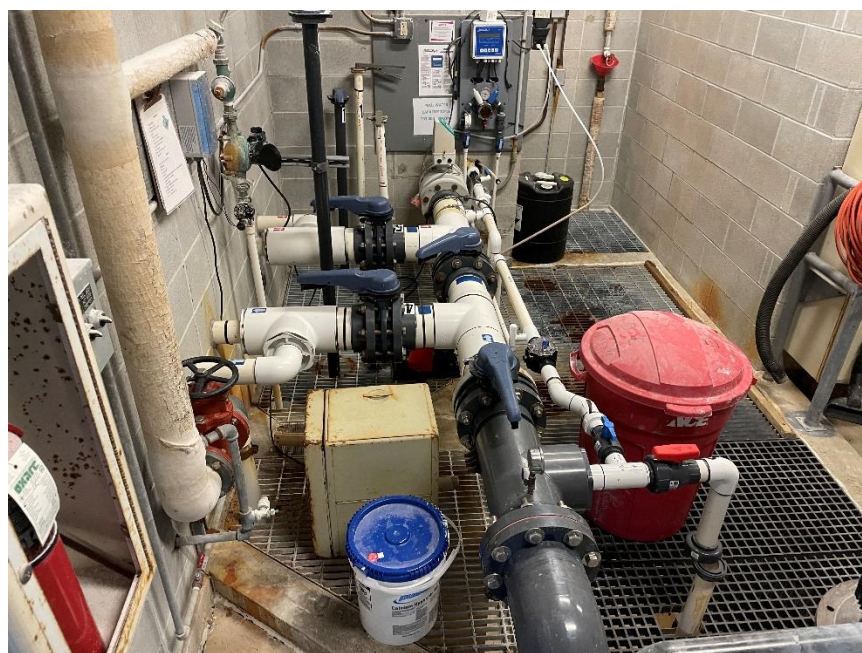
**Plate 10 – Corroded Grating Panels**

| Observations/Issues | Condition Rank |
|---|---|
| A room at the southeast portion of the building contains a concrete tank below grade. The top of the tank is covered with grating panels. Many of these grating panels and their ledger supports are significantly corroded and should be replaced <b>(Plate 10)</b> . | Failure |

Existing metal grating and ledger supports over the concrete tank within the southeast portion of the building are corroded and shall be removed and replaced with new galvanized grating and ledgers.

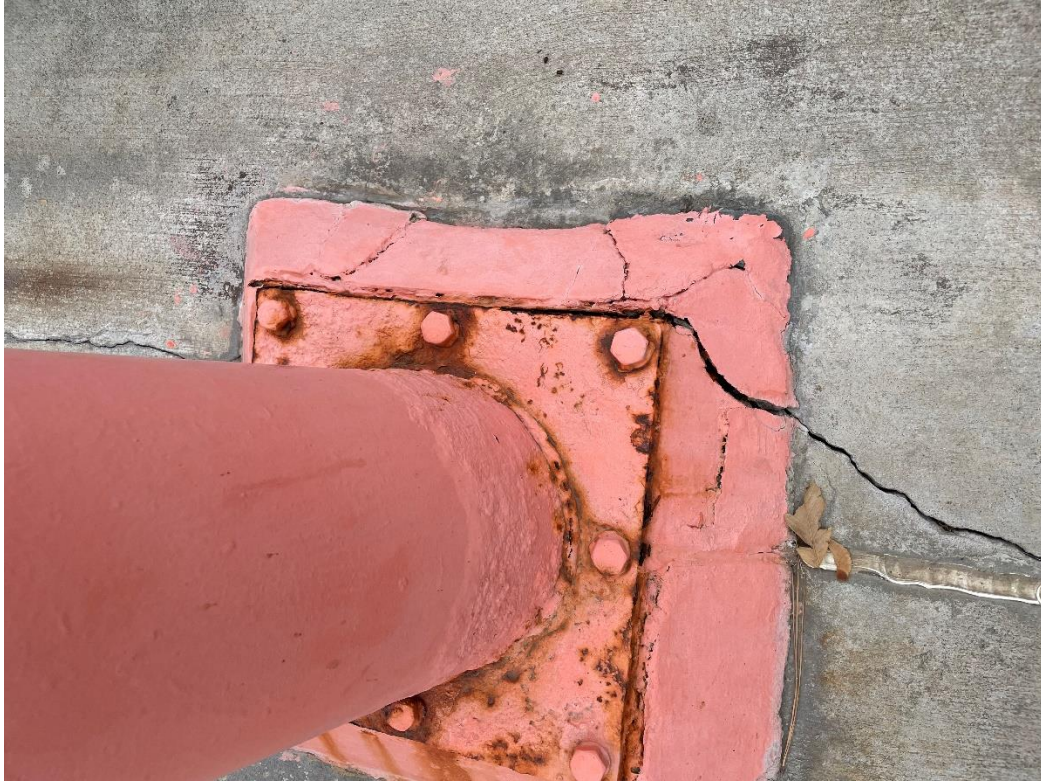
**Plate 11 – Concrete Crack at Diving Board Mounting Plate**

| Observations/Issues | Condition Rank |
|---|---|
| A large crack in the slab was found adjacent to the mounting plate for one of the diving boards <b>(Plate 11)</b> . | Poor |

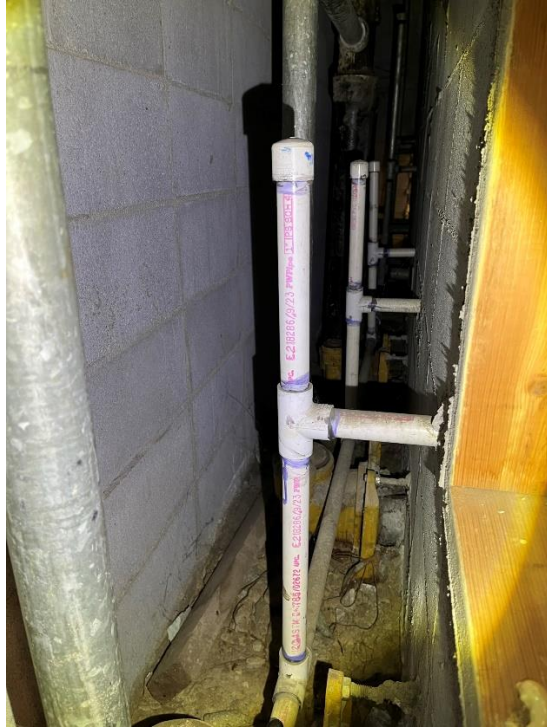
**Plate 13 – Men's Restroom Wall Chase**

| <b>Observations/Issues</b> | <b>Condition Rank</b> |
|---|---|
| Plumbing in Men's wall chase is not properly anchored to walls allowing some exposed plumbing to be loose <b>(Plate 13)</b> . | Poor |

The City may consider full replacement of the plumbing fixtures in both the Women's and Men's rooms (lavatories, waterclosets, urinals). While this is potentially an aesthetic upgrade, as these fixtures currently work, if the City pursues a larger facility rehabilitation effort, this is an item that would be recommended to be included within that larger project. If the City does not pursue this, fixtures that are loose or coming off walls should be repaired as soon as possible to prevent further damage.

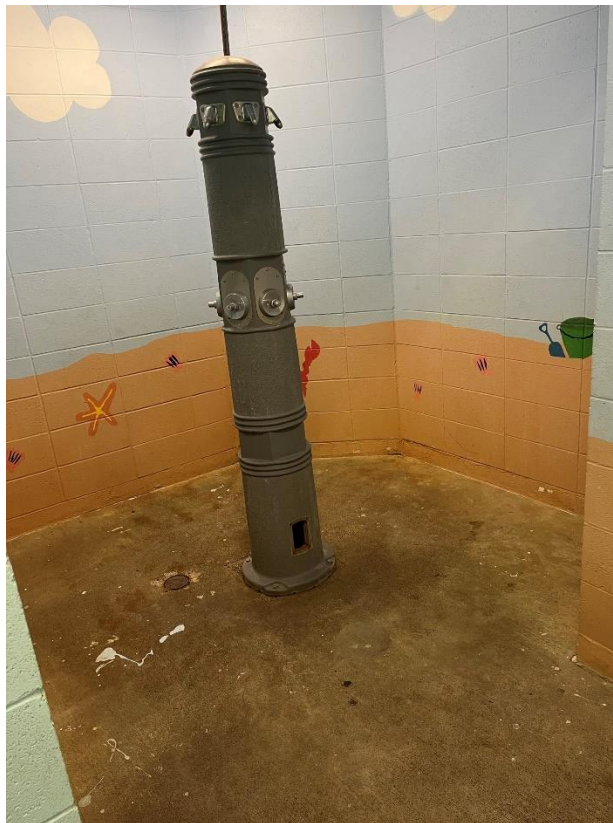
**Plate 14 – Men's Shower**

| <b>Observations/Issues</b> | <b>Condition Rank</b> |
|---|---|
| Men's column showers are corroded and close to becoming unserviceable <b>(Plate 14)</b> . | Poor |

It is recommended the City plan for replacement of the column showers in both the Women's and Men's shower rooms.

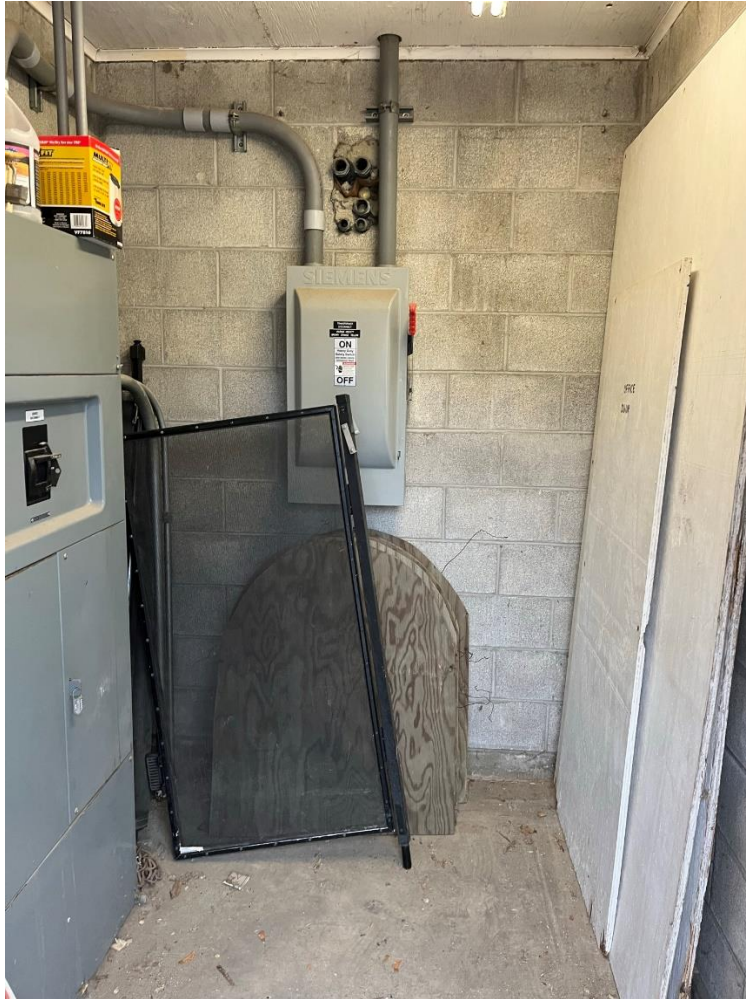
**Plate 15 – Electrical Gear Clearances**

The main electrical gear is required by the National Electrical Code (NEC) to have free and unobstructed dedicated space in front and above the equipment. NEC requires 48-inches or more space be maintained clear in front of the gear. Clutter in front of the electrical equipment can create a fire or possible life safety hazard for electrical work or maintenance

Replace the existing electrical gear with new and provide a new grounding system consisting of a grounding rod and associated grounding electrode conductors.

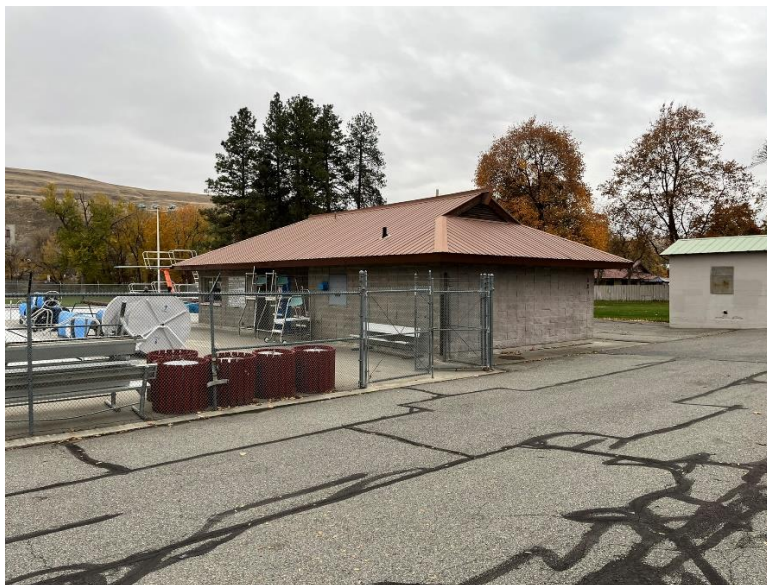
**Plate 16 – Asphalt Cracking**

| Observations/Issues | Condition Rank |
|---|---|
| Asphalt paved areas (facility entrance, parking, and interior access roads) all exhibit severe alligator cracking ( <b>Plate 16</b> ). | Poor |

Replace all deteriorated asphalt pavement, wheelstops, barrier curbs, curb ramp, and planter strip within the facility. Alligator cracking indicates failure of the pavement section and cracks allow water infiltration into the underlying materials, posing continued threat to deterioration of the asphalt pavement section, especially during freeze/thaw cycles.

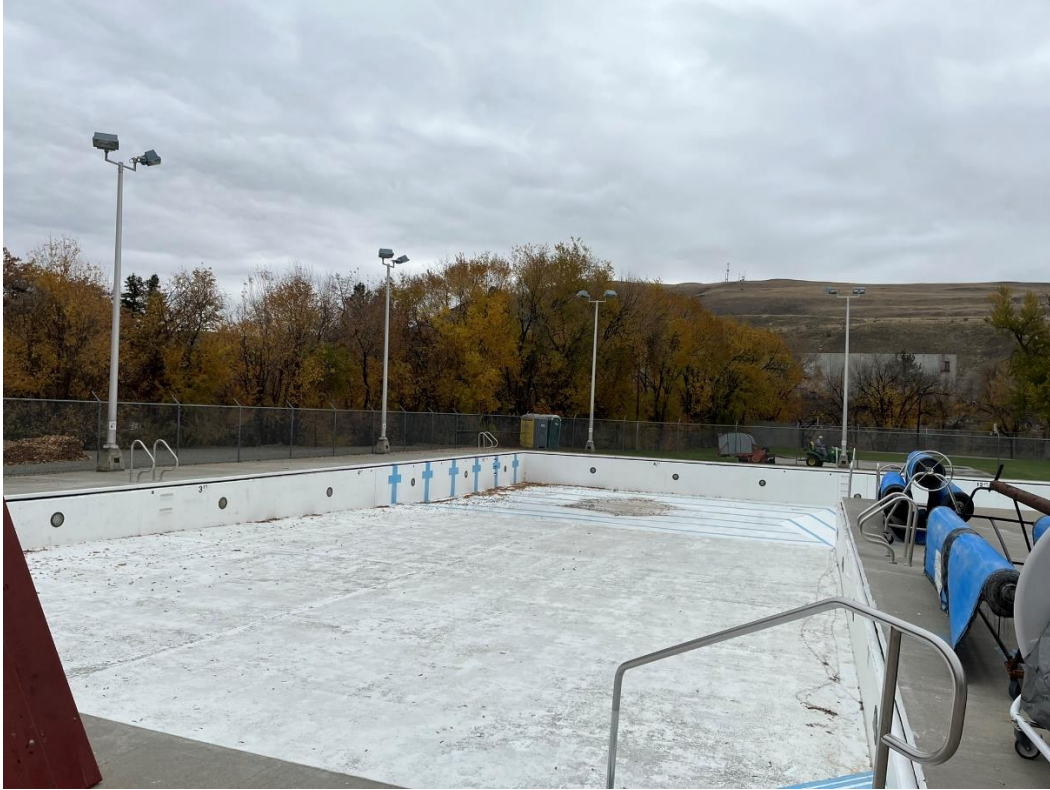
**Plate 17 – Pool Finish**

| Observations/Issues | Condition Rank |
|---|---|
| Pool Finish – painted w/significant wear and deterioration; spalling, delamination ( <b>Plate 17</b> ). | Poor |

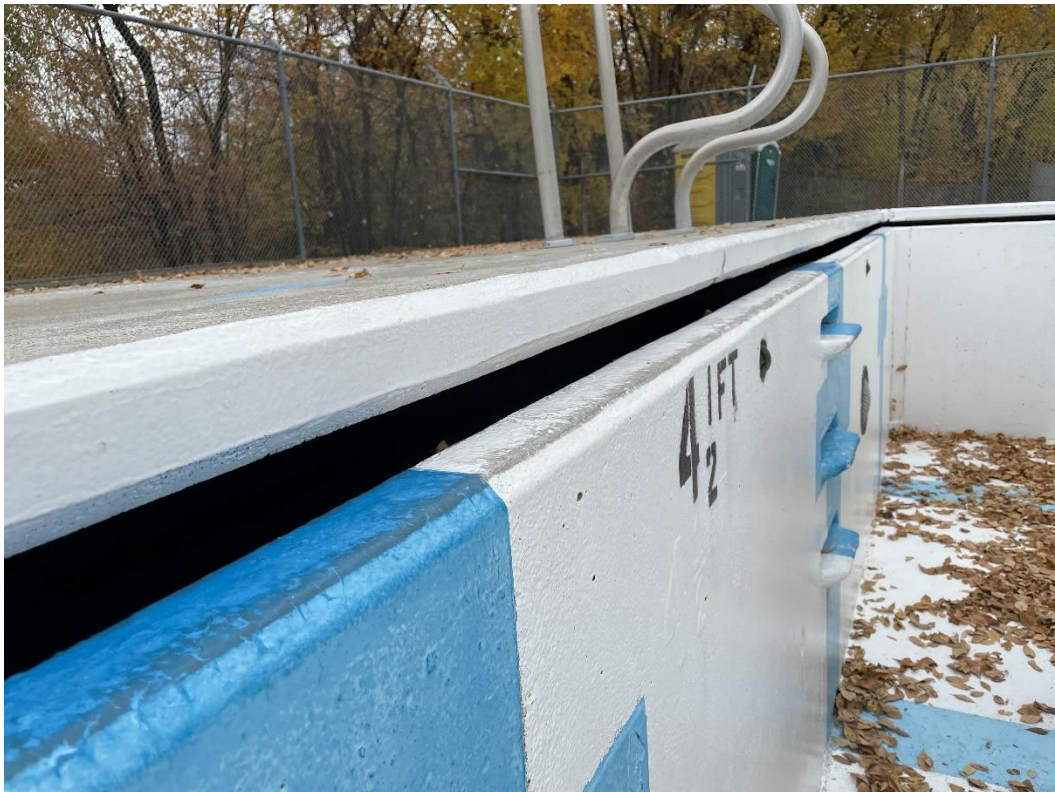
**Plate 18 – Pool Gutter Rim**

| Observations/Issues | Condition Rank |
|---|---|
| Pool Gutter – concrete w/significant cracking and spalling; insufficient rim flow, cracking and spalling ( <b>Plate 18</b> ). | Failing |

The current pool perimeter gutters are badly deteriorating. There are numerous cracks in the walls of the gutter and several areas of spalling concrete, some with exposed and corroded steel reinforcement. When the concrete reinforcement is corroding, the strength

of the concrete structure is weakening and will continue to break apart and, at some point, fail completely if not properly repaired. Cracking in the gutter as well as joints in the gutter are suspected of being the source of leaking pool water.

The existing gutter should be replaced with a new deck level perimeter gutter with PVC gutter grating. The existing gutter should be demolished, and a new gutter installed utilizing the Myrtha RenovAction system. Myrtha Pools is a manufacturer of PVC laminated stainless steel pool vessel systems and custom fabricates replacement gutters for existing pools. This system has the benefits of fast construction and installation timelines, the precision of factory fabricated stainless steel, and durability and resistance of the hot calendared PVC finish.

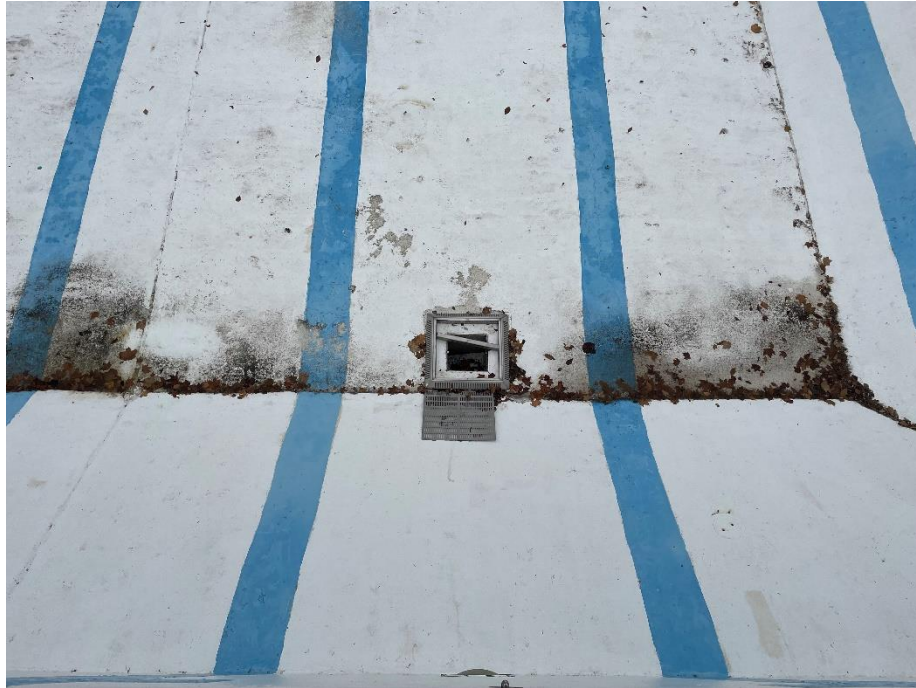
**Plate 19 – Main Drain with Retrofit Cover**

| <b>Observations/Issues</b> | <b>Condition Rank</b> |
|---|---|
| Main Drains – dual w/retrofit covers; location and quantity acceptable; recommend facility check for records of drain sump VGBA compliance <b>(Plate 19)</b> . | Fair |

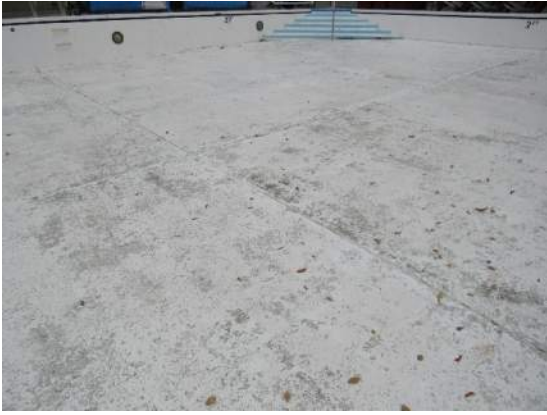
Floor of pool in shallow area, deteriorating paint finish

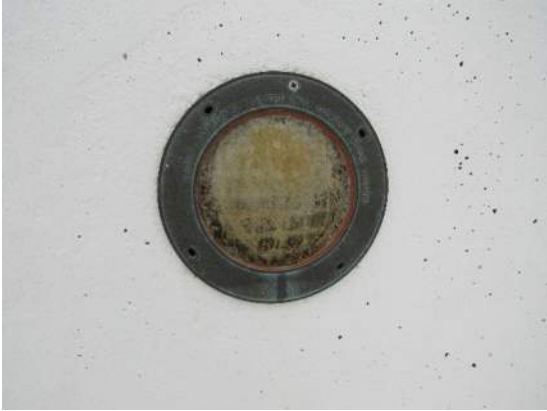
Underwater light with corrosion and mineral buildup

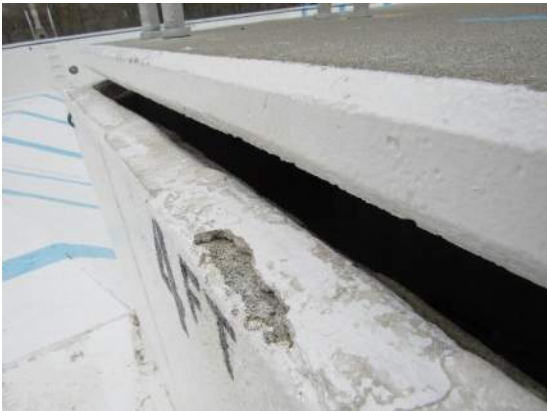
Gutter edge with spalling concrete

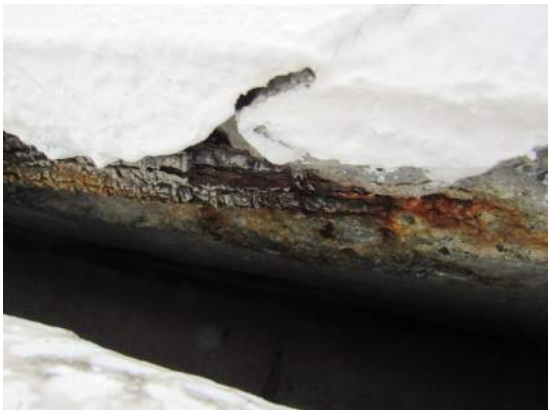
Spalling in gutter with exposed and corroded reinforcement

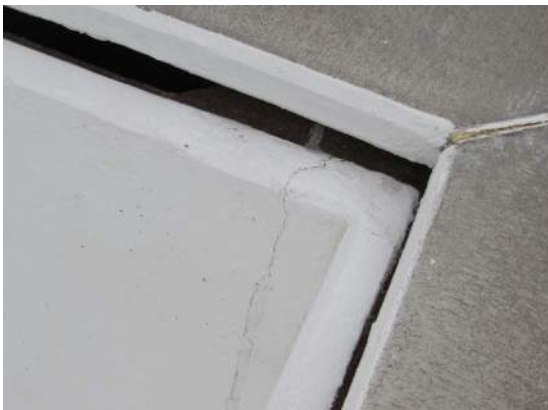
Vertical cracking along gutter and pool wall

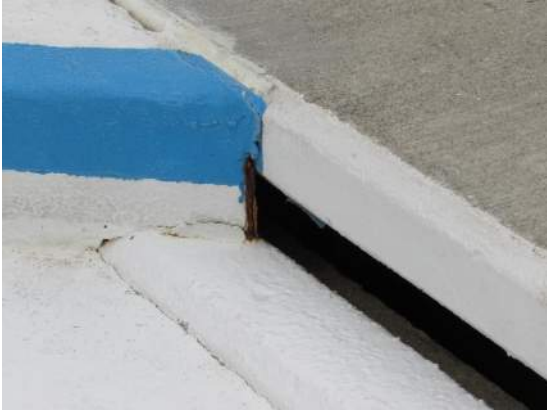
Cracking at joints of stairs with exposed and corroded reinforcement

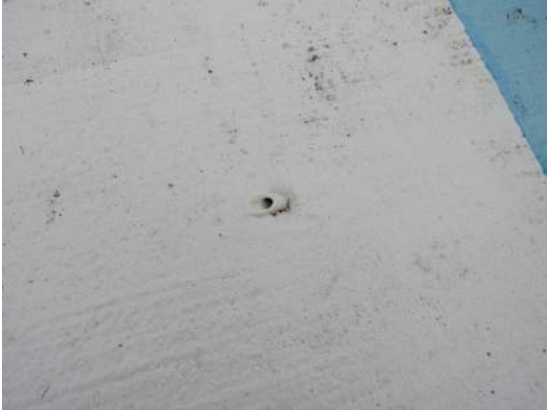
Stubbed floor return in pool floor
