# CITY OF OKANOGAN

## OKANOGAN POOL FACILITY ASSESSMENT

G&O #21854  
FEBRUARY 2024

**Gray & Osborne, Inc.**  
CONSULTING ENGINEERS

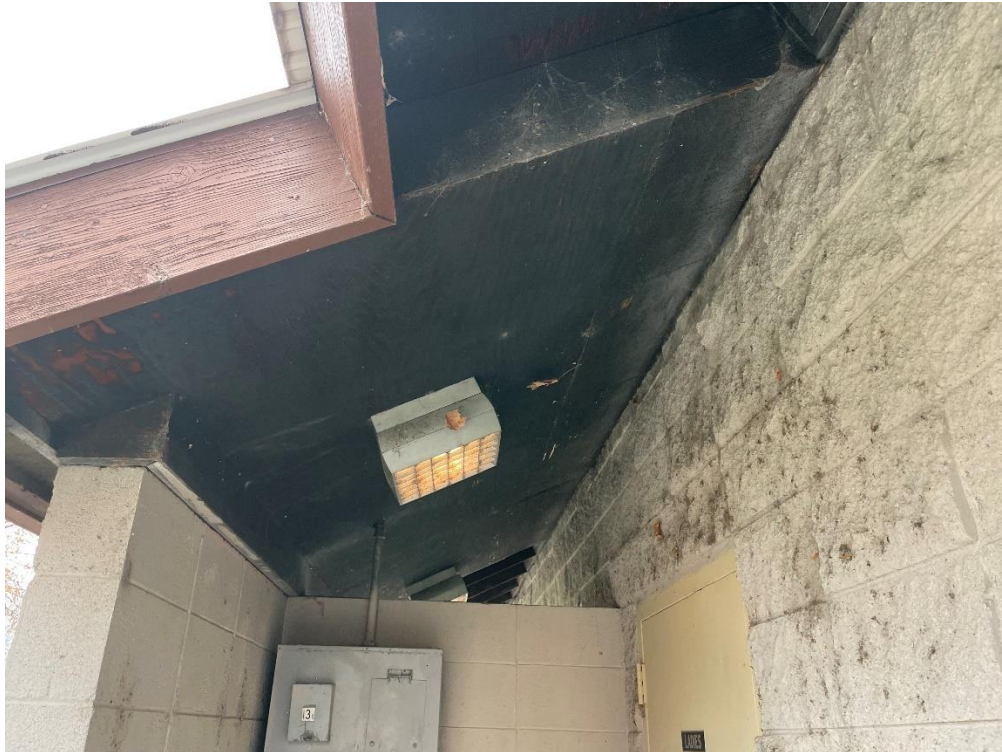
**Plate 1 – Exterior Wood Fascia and Soffit Peeling Paint**

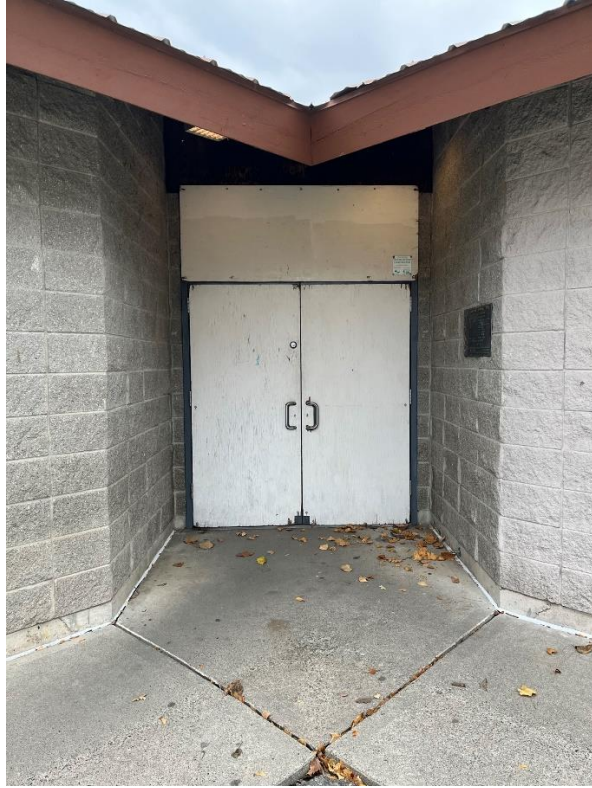
**Plate 3 – Front Entrance Boarded Doors and Relite**

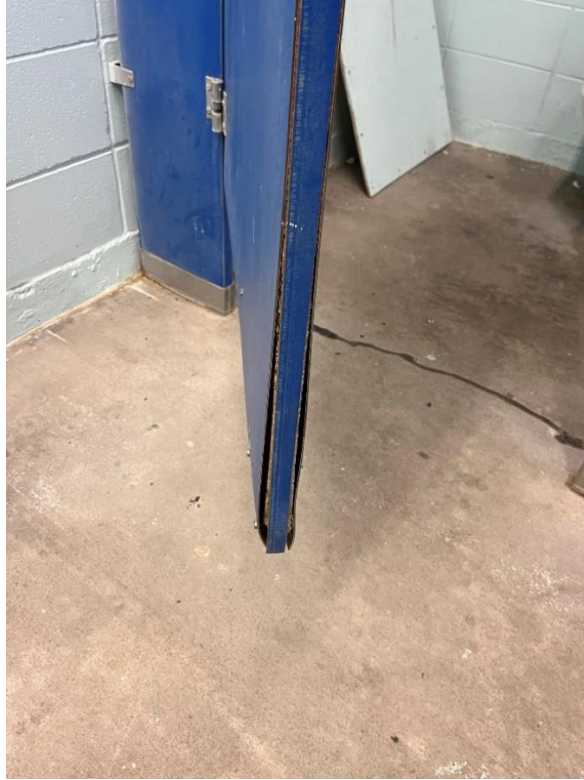
| <b>Observations/Issues</b> | <b>Condition Rank</b> |
|---|---|
| Men's stall partitions are damaged and beginning to delaminate <b>(Plate 7)</b> . | Poor |

**Plate 7 – Stall Door Delamination**

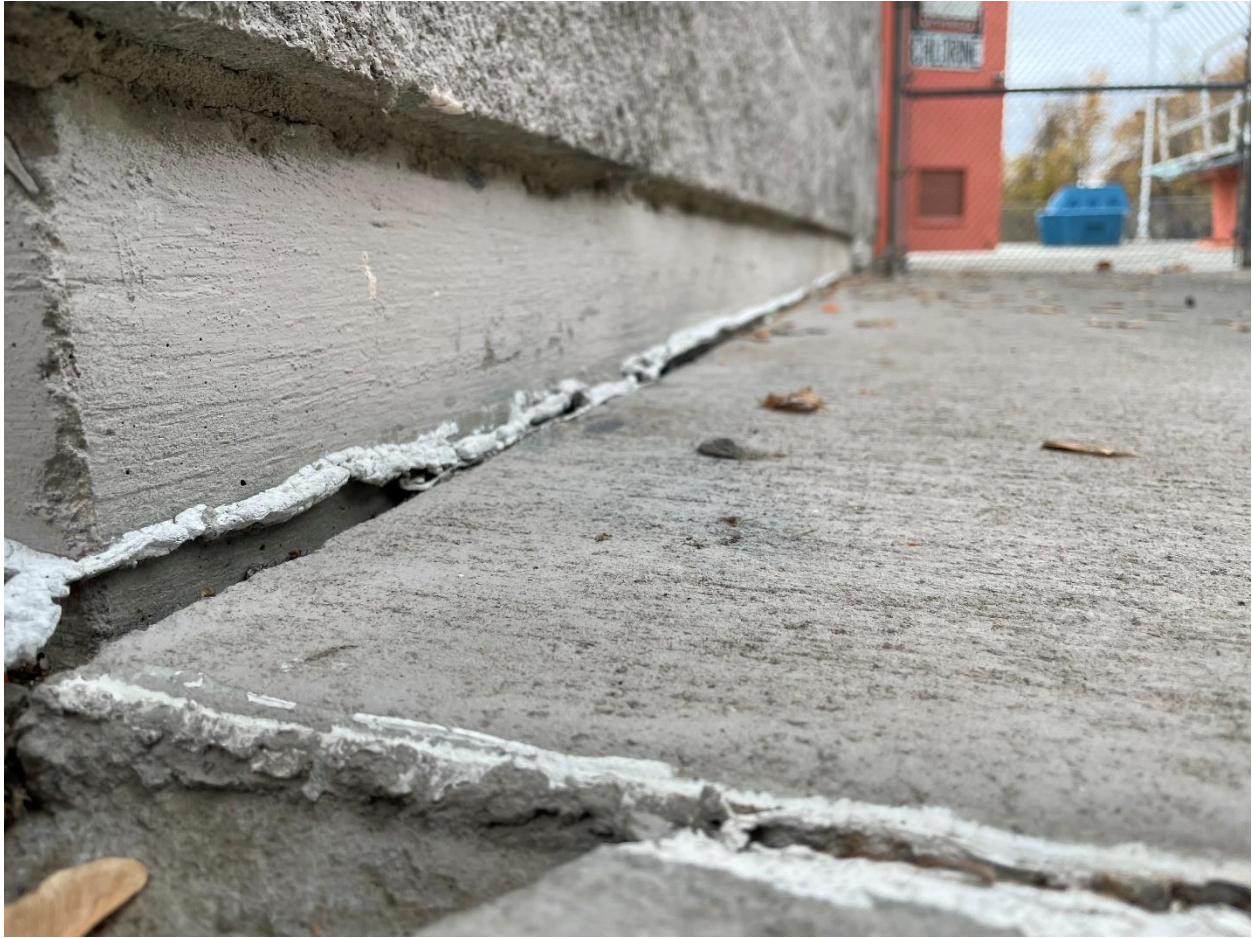
| Observations/Issues | Condition Rank |
|---|---|
| The settlement of the sidewalk is particularly noticeable at the southeast corner of the building, where sidewalk that originally was flush with the building floor at the doorway has settled more than 2”. We understand there is piping between the building and pool under this sidewalk and there is concern that a leak in the pipe may have caused some soil voids under this area <b>(Plate 9)</b> . | Poor |

**Plate 9 – Sidewalk Settlement**

In general cracking and settlement in the concrete sidewalks around the building shall be addressed with grinding and grouting to make surfaces smooth, or by replacing the affected sidewalk panels. At the southeast corner of the building where settlement of the sidewalk is most extreme, it may be prudent to remove all sidewalk panels and excavate to exposed below grade piping to verify if there is piping leakage that is creating voids under the sidewalk.

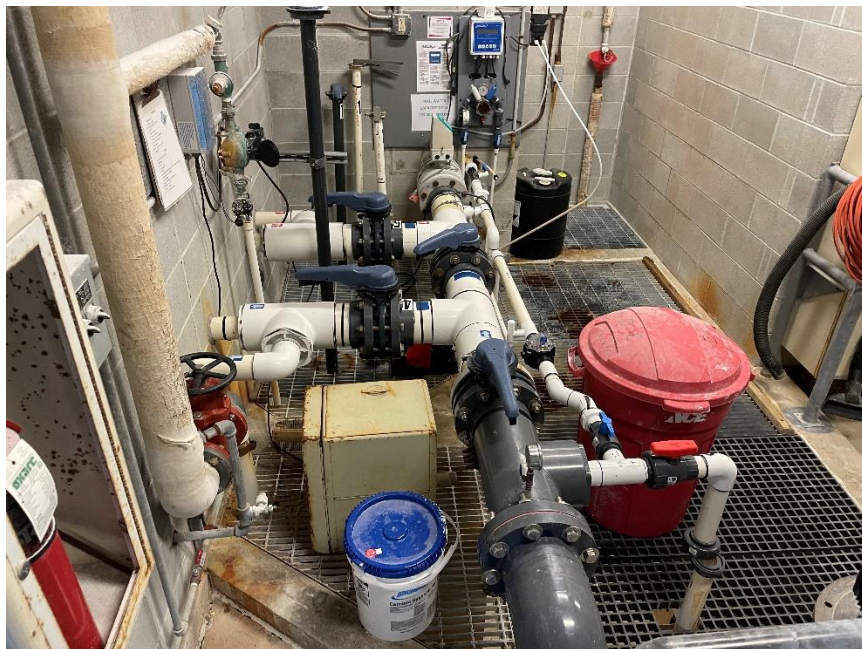
| Observations/Issues | Condition Rank |
|---|---|
| A room at the southeast portion of the building contains a concrete tank below grade. The top of the tank is covered with grating panels. Many of these grating panels and their ledger supports are significantly corroded and should be replaced <b>(Plate 10)</b> . | Failure |

**Plate 10 – Corroded Grating Panels**

Existing metal grating and ledger supports over the concrete tank within the southeast portion of the building are corroded and shall be removed and replaced with new galvanized grating and ledgers.

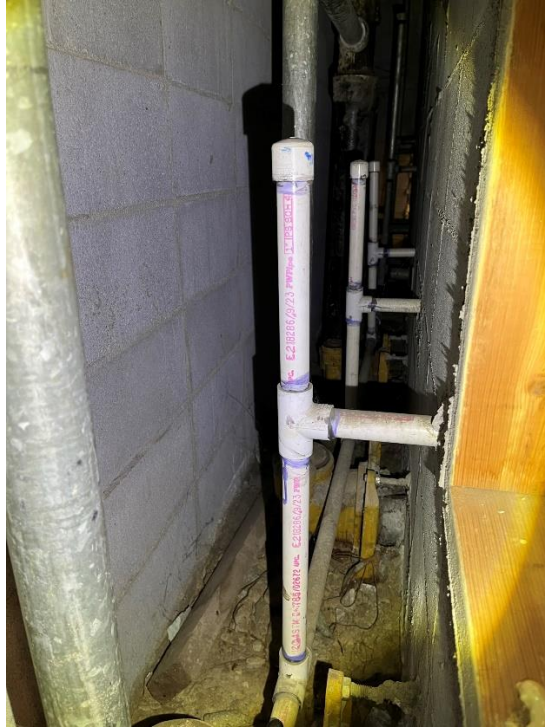
| <b>Observations/Issues</b> | <b>Condition Rank</b> |
|---|---|
| Plumbing in Men's wall chase is not properly anchored to walls allowing some exposed plumbing to be loose <b>(Plate 13)</b> . | Poor |

**Plate 13 – Men's Restroom Wall Chase**

The City may consider full replacement of the plumbing fixtures in both the Women's and Men's rooms (lavatories, waterclosets, urinals). While this is potentially an aesthetic upgrade, as these fixtures currently work, if the City pursues a larger facility rehabilitation effort, this is an item that would be recommended to be included within that larger project. If the City does not pursue this, fixtures that are loose or coming off walls should be repaired as soon as possible to prevent further damage.

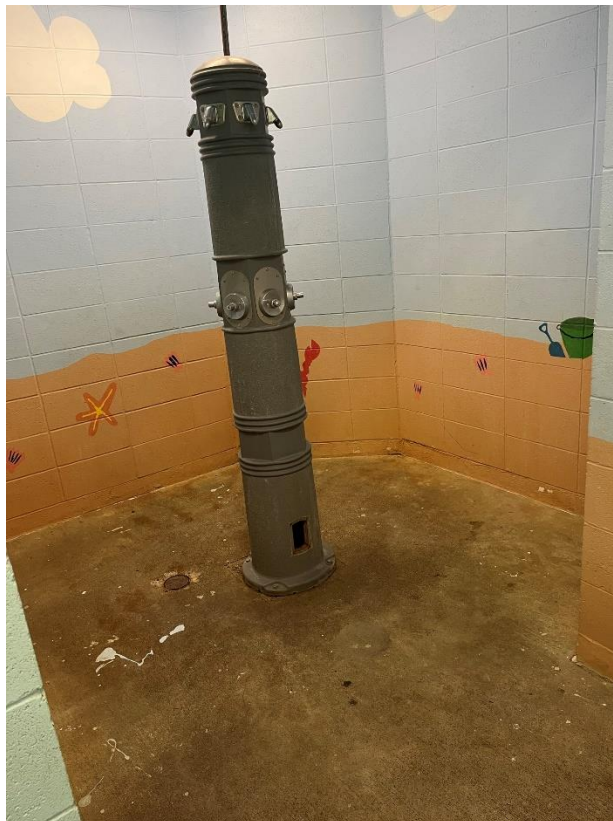
| <b>Observations/Issues</b> | <b>Condition Rank</b> |
|---|---|
| Men's column showers are corroded and close to becoming unserviceable <b>(Plate 14)</b> . | Poor |

**Plate 14 – Men's Shower**

It is recommended the City plan for replacement of the column showers in both the Women's and Men's shower rooms.

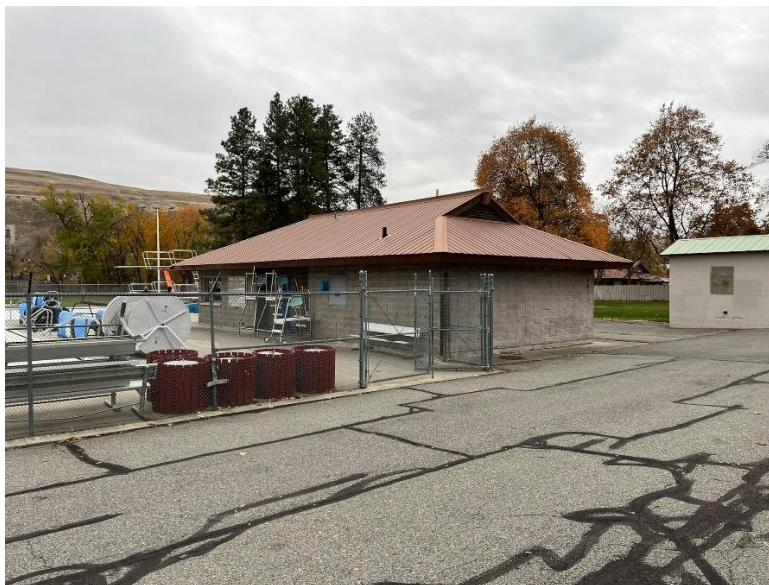
| Observations/Issues | Condition Rank |
|---|---|
| Asphalt paved areas (facility entrance, parking, and interior access roads) all exhibit severe alligator cracking ( <b>Plate 16</b> ). | Poor |

**Plate 16 – Asphalt Cracking**

Replace all deteriorated asphalt pavement, wheelstops, barrier curbs, curb ramp, and planter strip within the facility. Alligator cracking indicates failure of the pavement section and cracks allow water infiltration into the underlying materials, posing continued threat to deterioration of the asphalt pavement section, especially during freeze/thaw cycles.

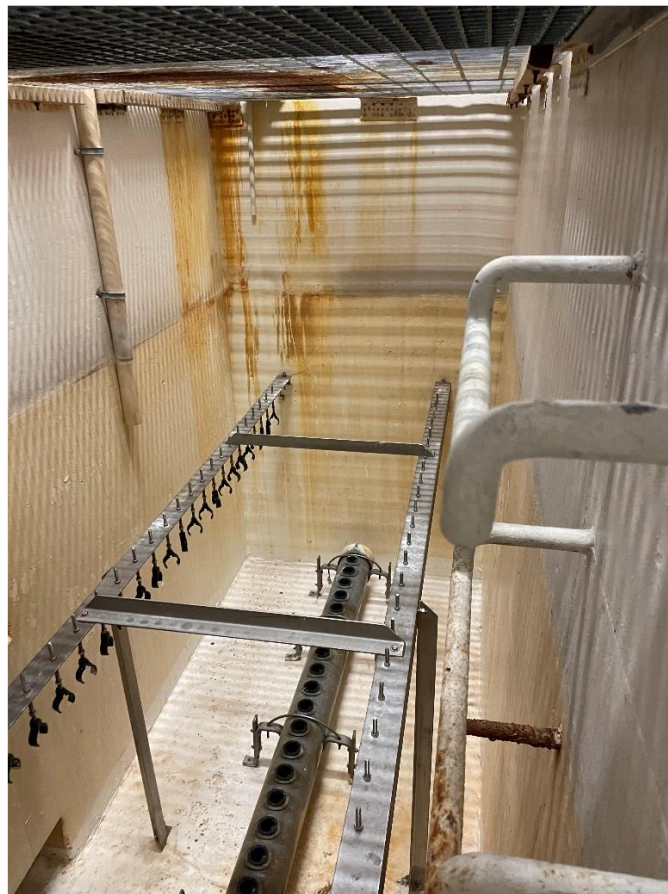
**Plate 20 – Vacuum DE Filter Tank**

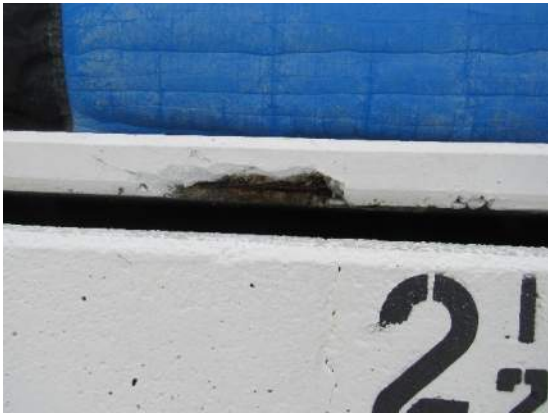
Gutter parapet with chipping and cracking

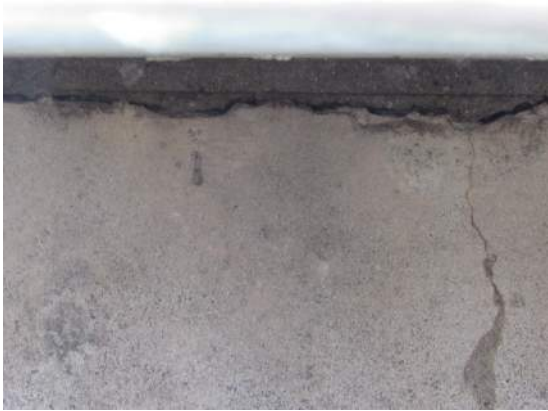
Cracking in the back of gutter

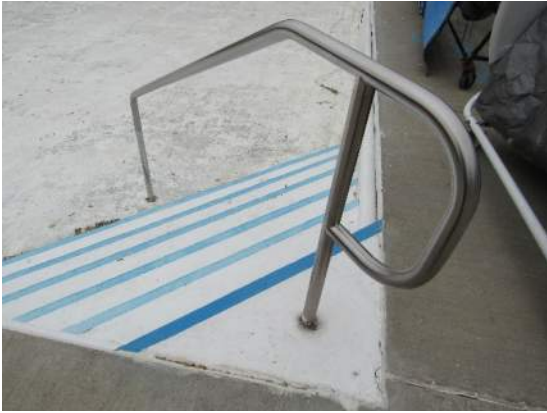
Entry steps with handrail, not ADA compliant

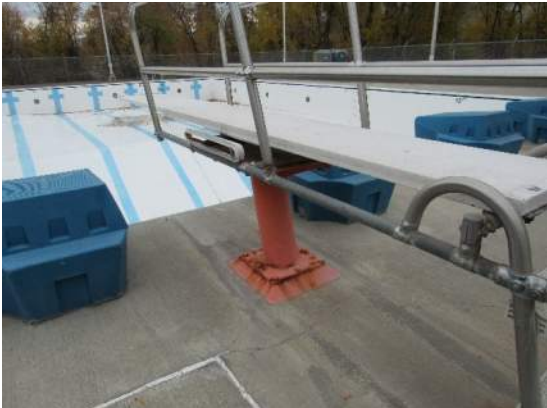
1-meter diving board with severely corroded stand base

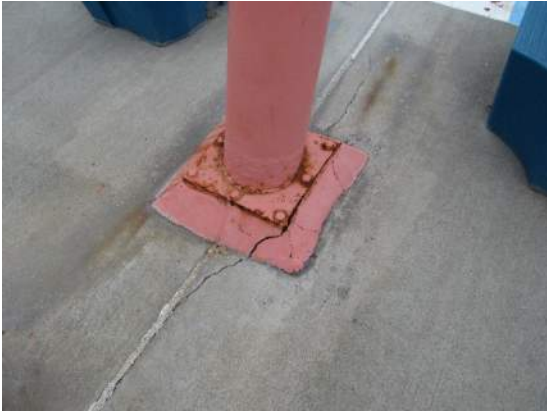
3-meter diving board stand base, severely corroded and cracking

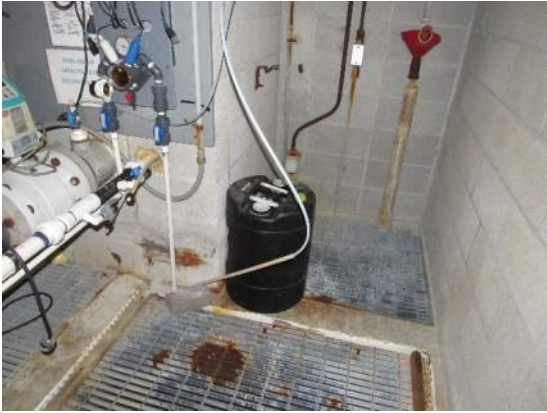
Hydrochloric acid stored in mechanical room

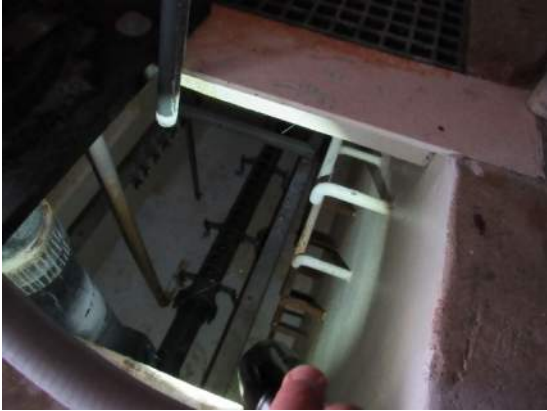
Vacuum DE filter tank with DE grids removed
